82543GC Gigabit Ethernet Controller Specification Update

Revision 2.1

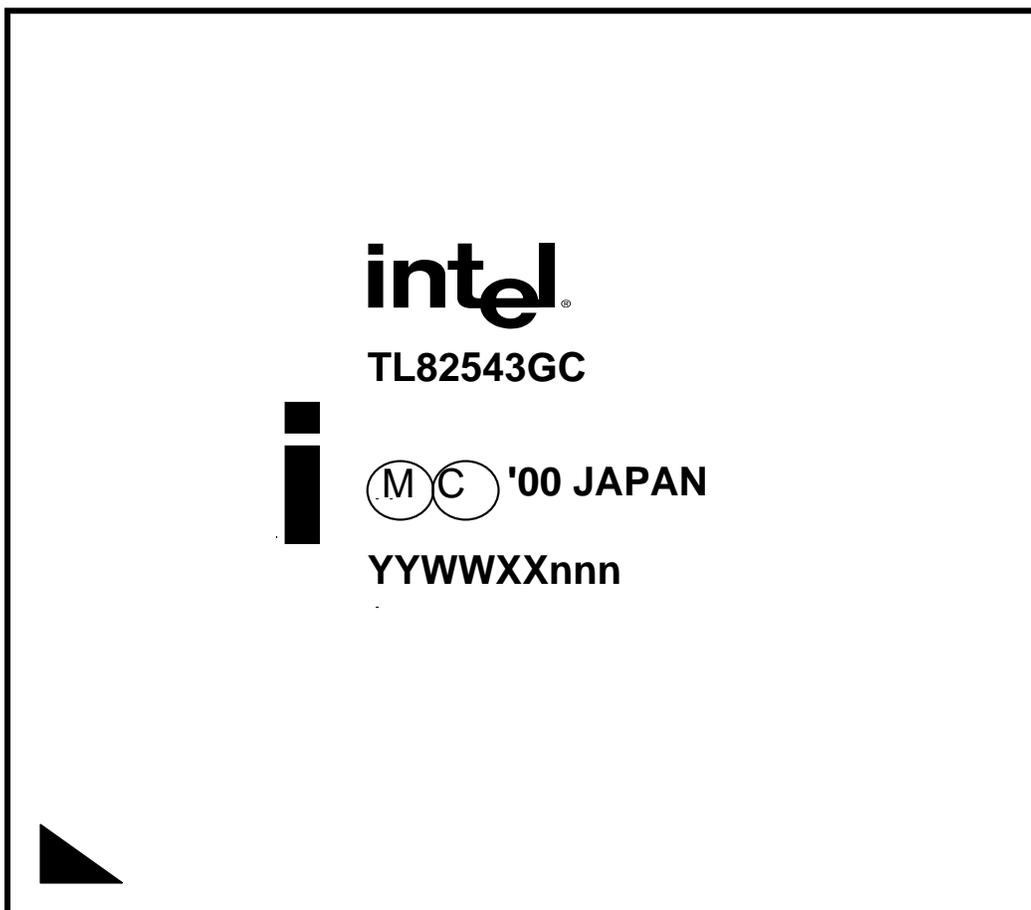
82543GC COMPONENT MARKING INFORMATION

The legend for the manufacturing code is as follows:

- YY = Assembly input year
- WW = Assembly workweek
- XXnnn = Complete lot traceability code (use for issue reporting)
- XX = Mask/assembly spec
- nnn = Lot history code

Stepping	QDF Number	S- Spec Number	Top Marking	Notes
A0	Q415	S L3N8	FW82543GC	Engineering Samples. May be marked with either QDF number or S-spec number.
A1	Q416	S L3N9	FW82543GC	Engineering Samples. May be marked with either QDF number or S-spec number.
A2	Q417	N/A	FW82543GC or TL82543GC	Engineering Samples. May be marked two ways: with the QDF number and a top mark FW82543GC; or without any QDF or S-spec number, and a top mark TL82543GC.
	N/A	N/A	TL82543GC	Production Devices. Marked without QDF or S-spec numbers and bear a top mark TL82543GC.
